...FASTENERS

Recently, Red Man Aviation in Tulsa, Oklahoma, had the opportunity to perform some fastener replacement and doubler installations on several clients' aircraft. These planes exhibited some common aging aircraft issues that we thought would interest the Aerostar Owners Association.

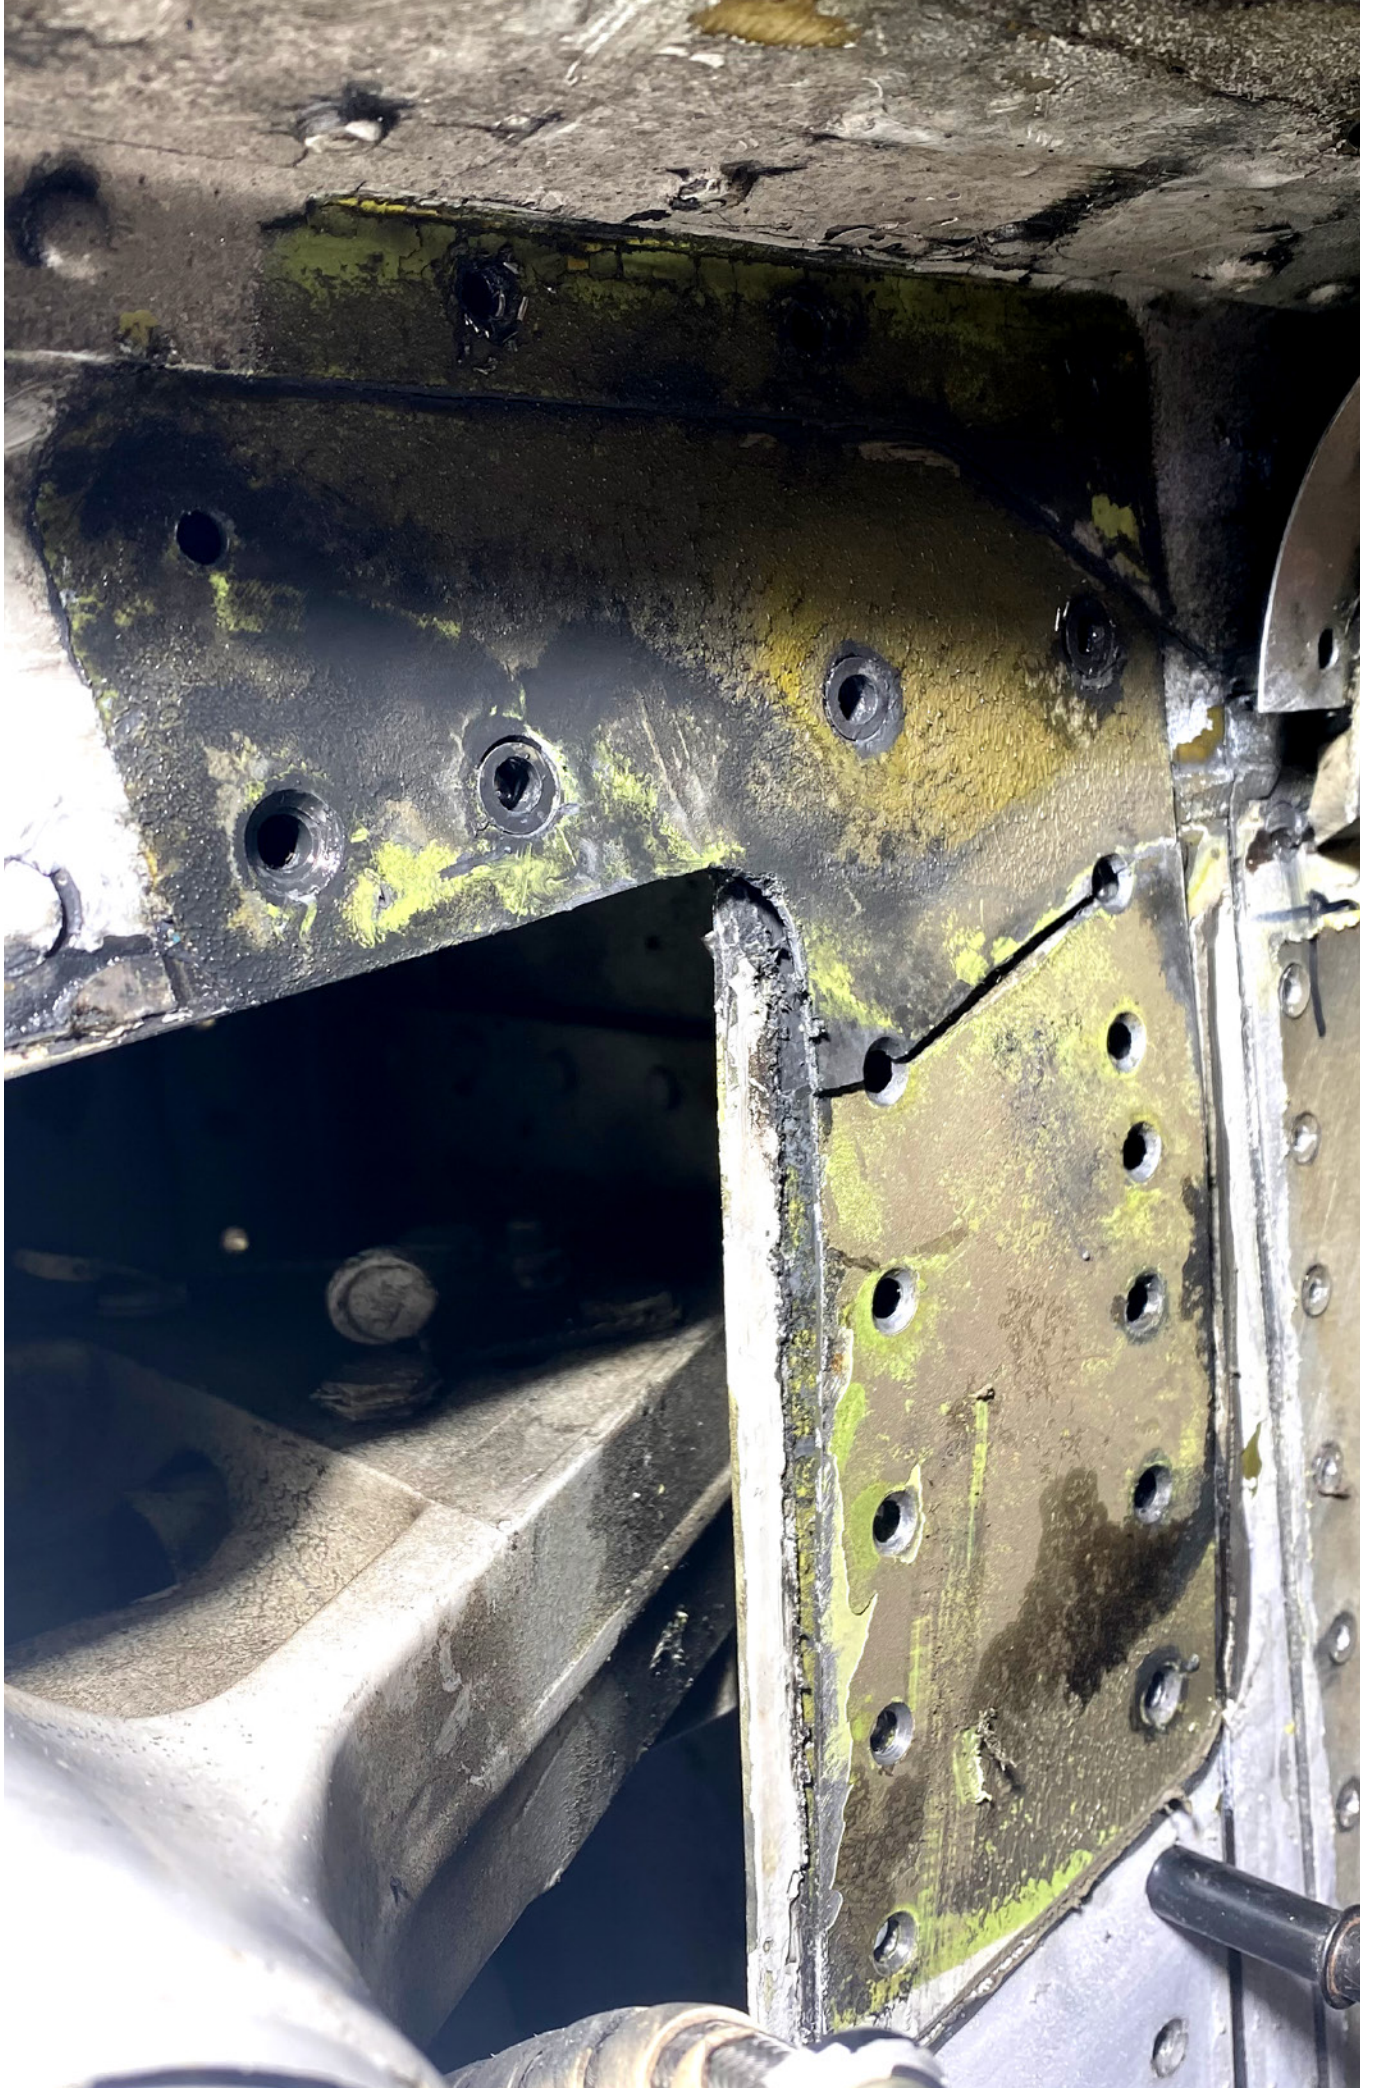
This page

The picture above and the following page is an excellent exemplar of the visual indications of what one might see on their aircraft, possibly indicating that fasteners are beginning to “work.” Further investigation on the two aircraft we observed suggested that the fasteners were loose and could be “spun” in place. This led to some very trying times when attempting to cut the Cherry or Huck locking collars and drilling the fasteners out during the removal process. The loose fasteners found were limited to the spar caps and the aft, intercostal, and trailing edges.

Example of the visual indications of what one might see on their aircraft possibly indicating that fasteners are beginning to “work.”

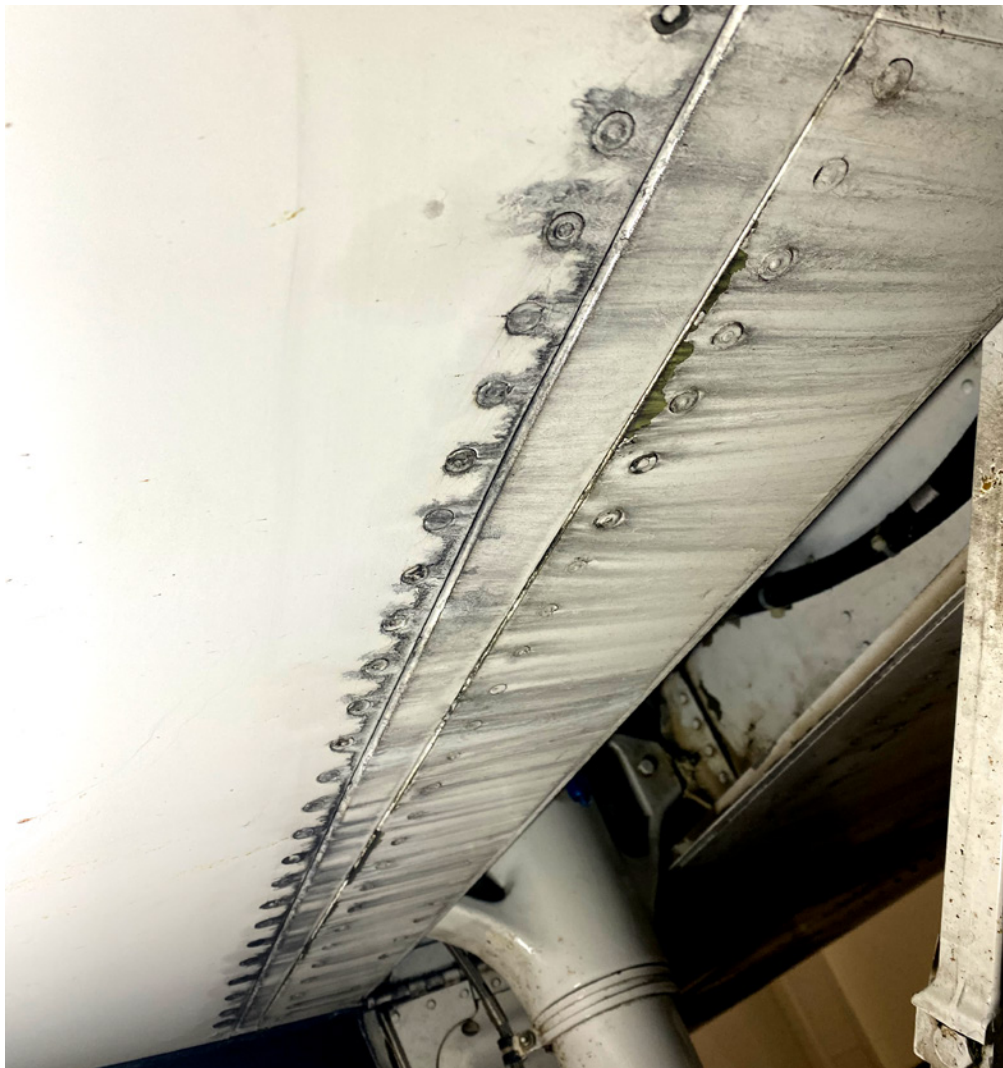
The photo to the right is of the underside of the right wing between the respective wing stations illustrates the possibility of fasteners working. A better assessment of the condition of the fastener can be gained by pressing on the fastener or the adjacent skin to visually check for movement. In several instances, we were able to get the movement of the skin. Still, we could physically “wiggle” the fastener in position.

Top
Underside of the right wing between the respective wing stations illustrates the possibility of fasteners working.

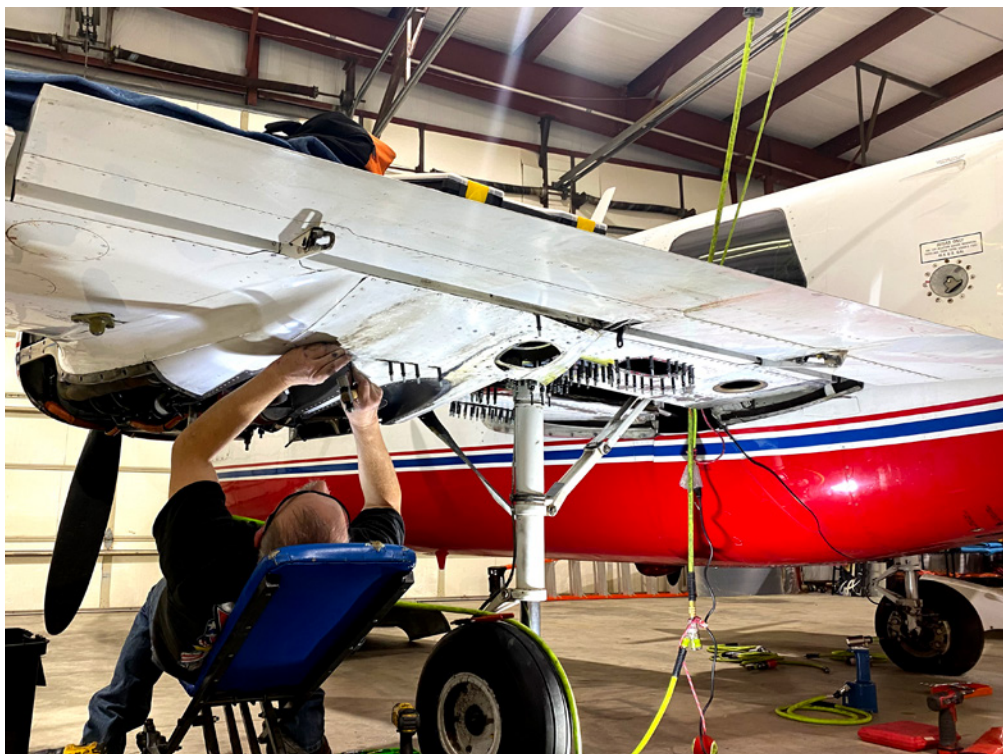
Bottom
Replacing fasteners

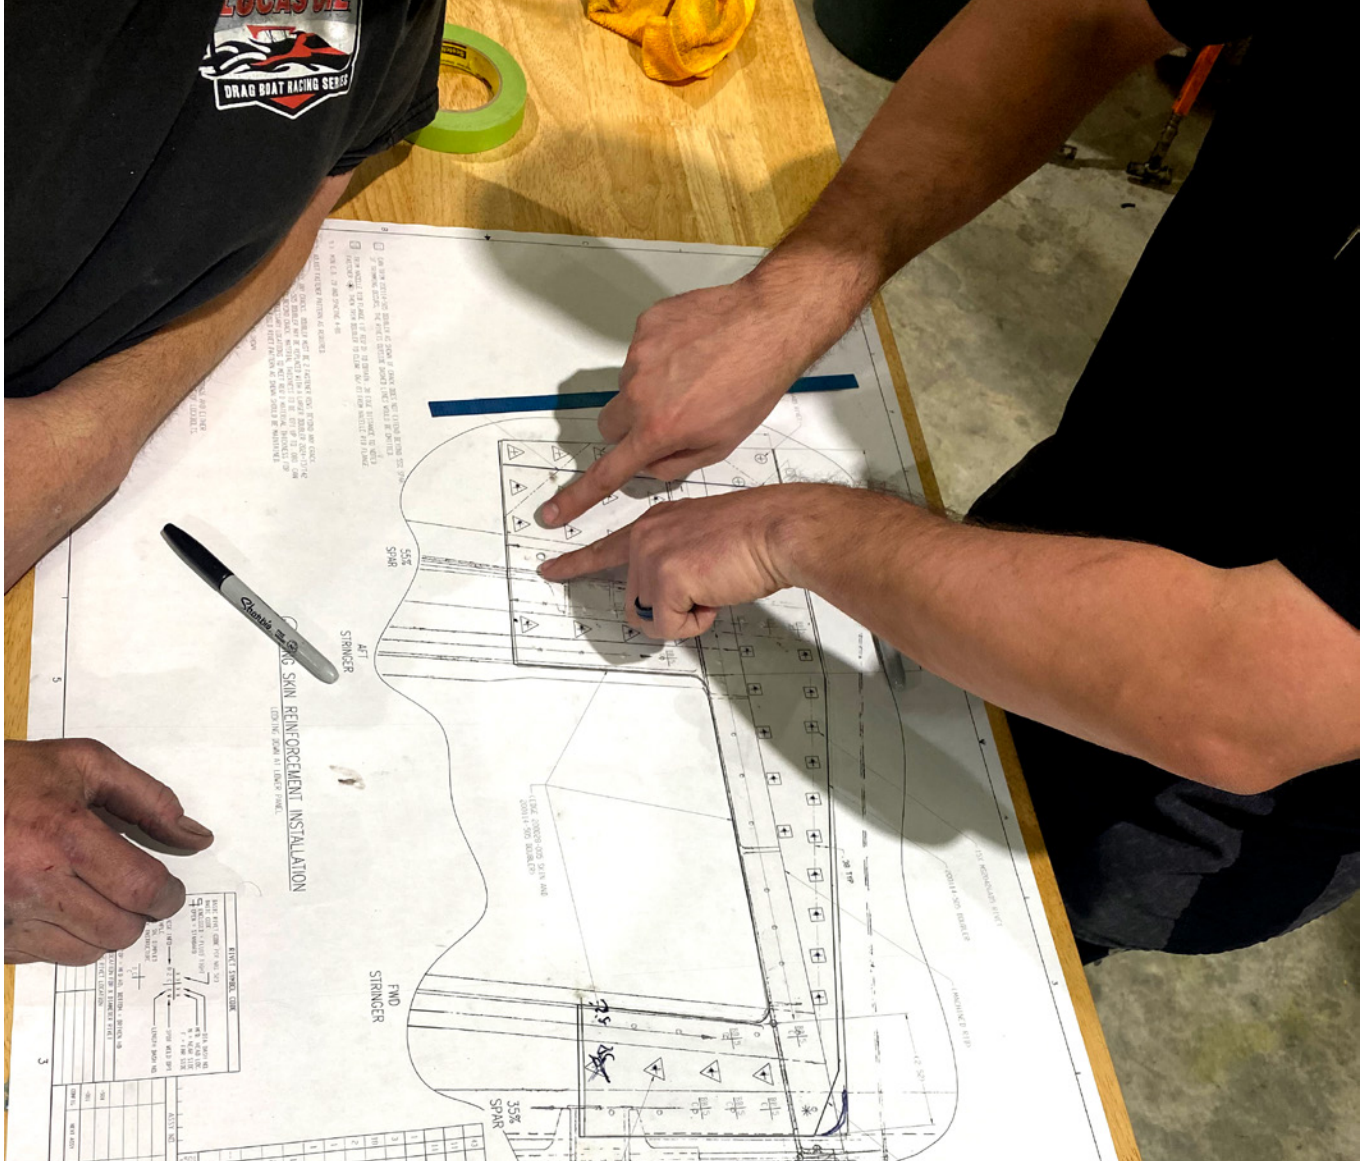
This page

Preparation includes a thorough review all the notes and drawings. Drawings were provided by Aerostar Aircraft.

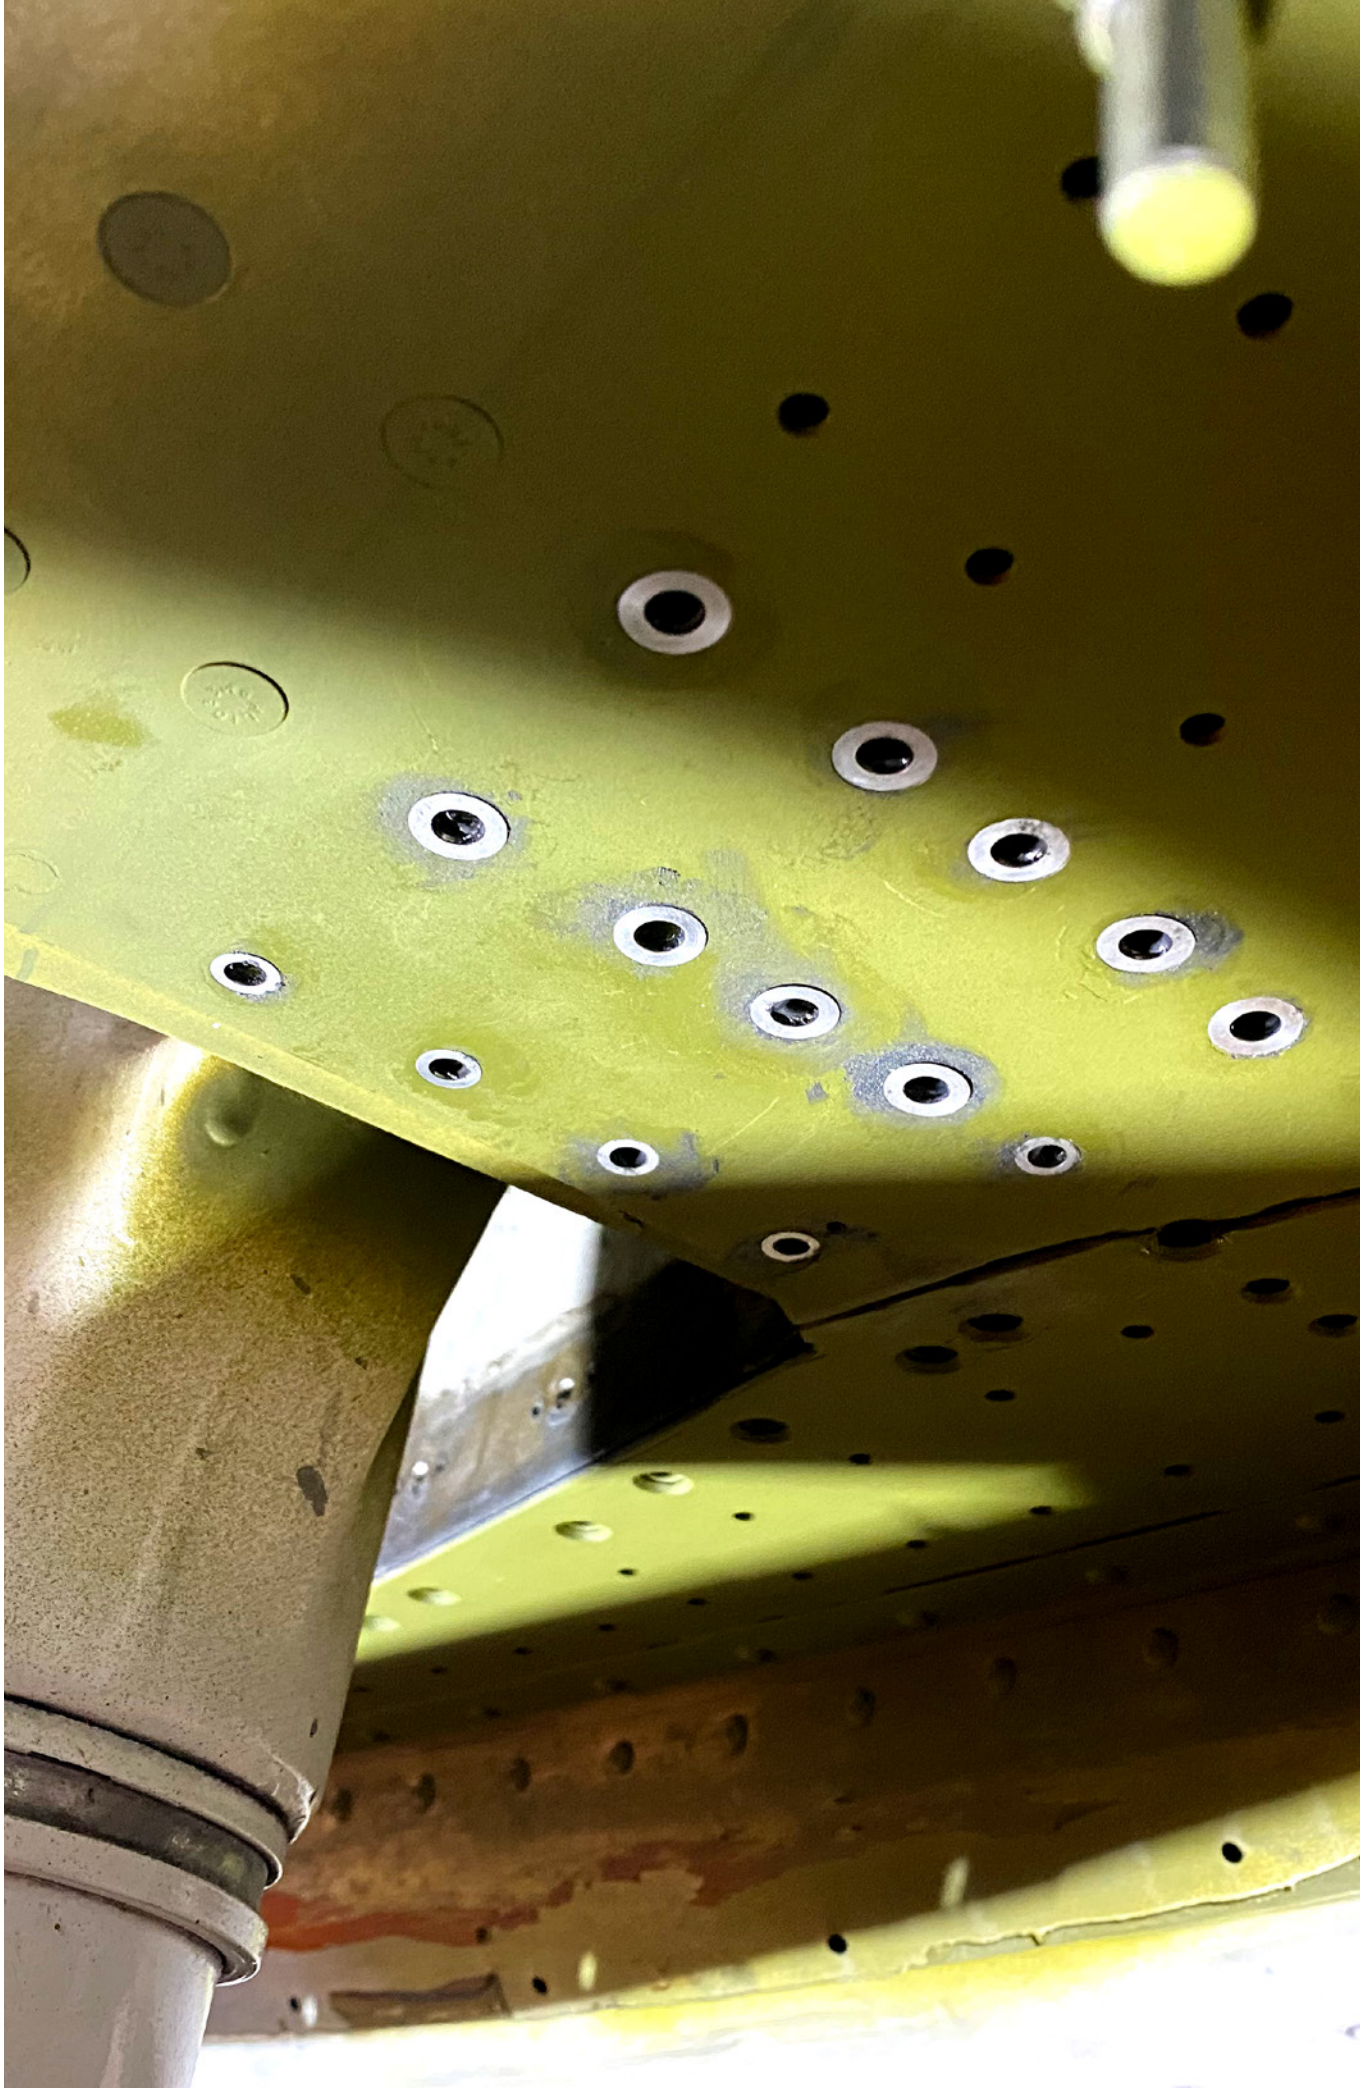
Opposite

Each & every individual hole has to be measured and checked for each and every fastener.

In some cases, the fastener hole is “out of round” due to a previous working fastener. It must be reamed to the first or second oversized dimension. This required each individual hole to be measured and checked for each fastener. In addition to the proper diameter of each hole, we ob-

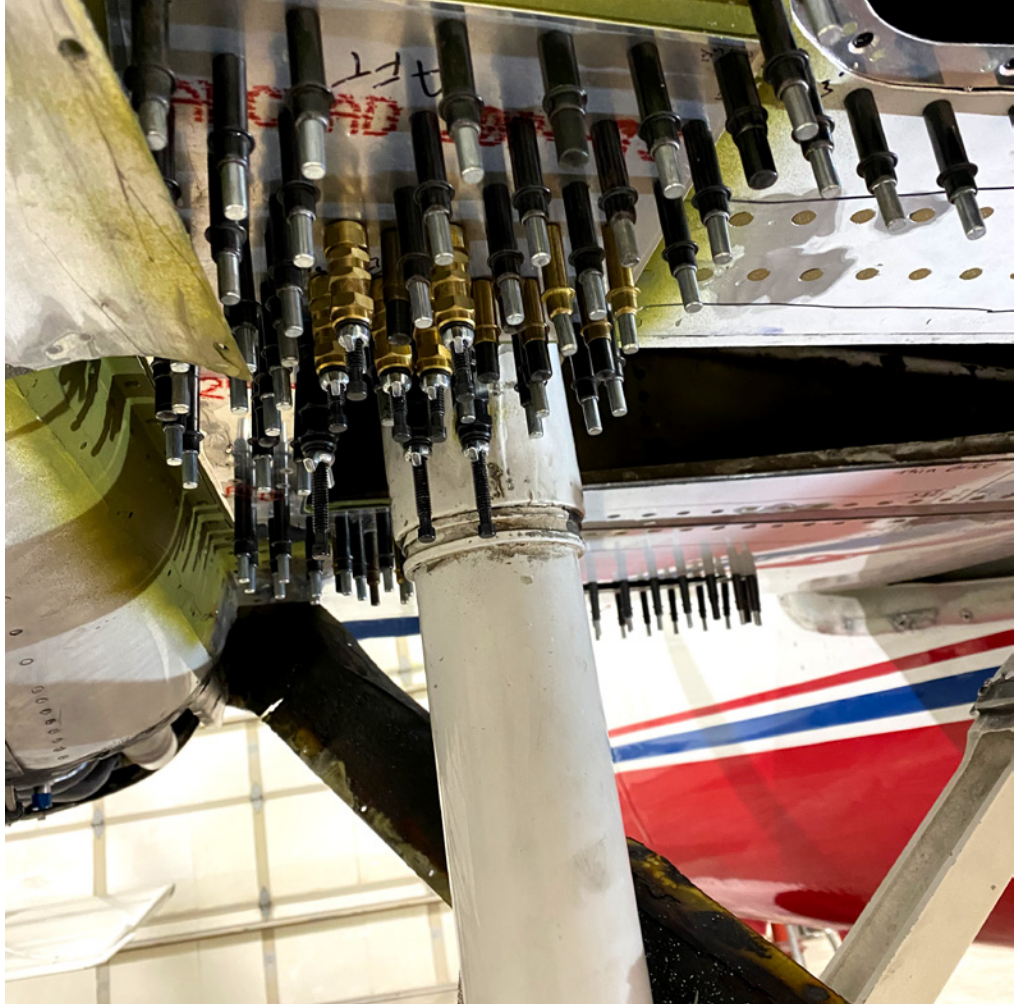
Top

Trailing edge of wing looking forward illustrating typical doubler position underside of left wing. Doubler aft of gear trunnions must extend to include at least two fastener rows past any cracks in original skin.

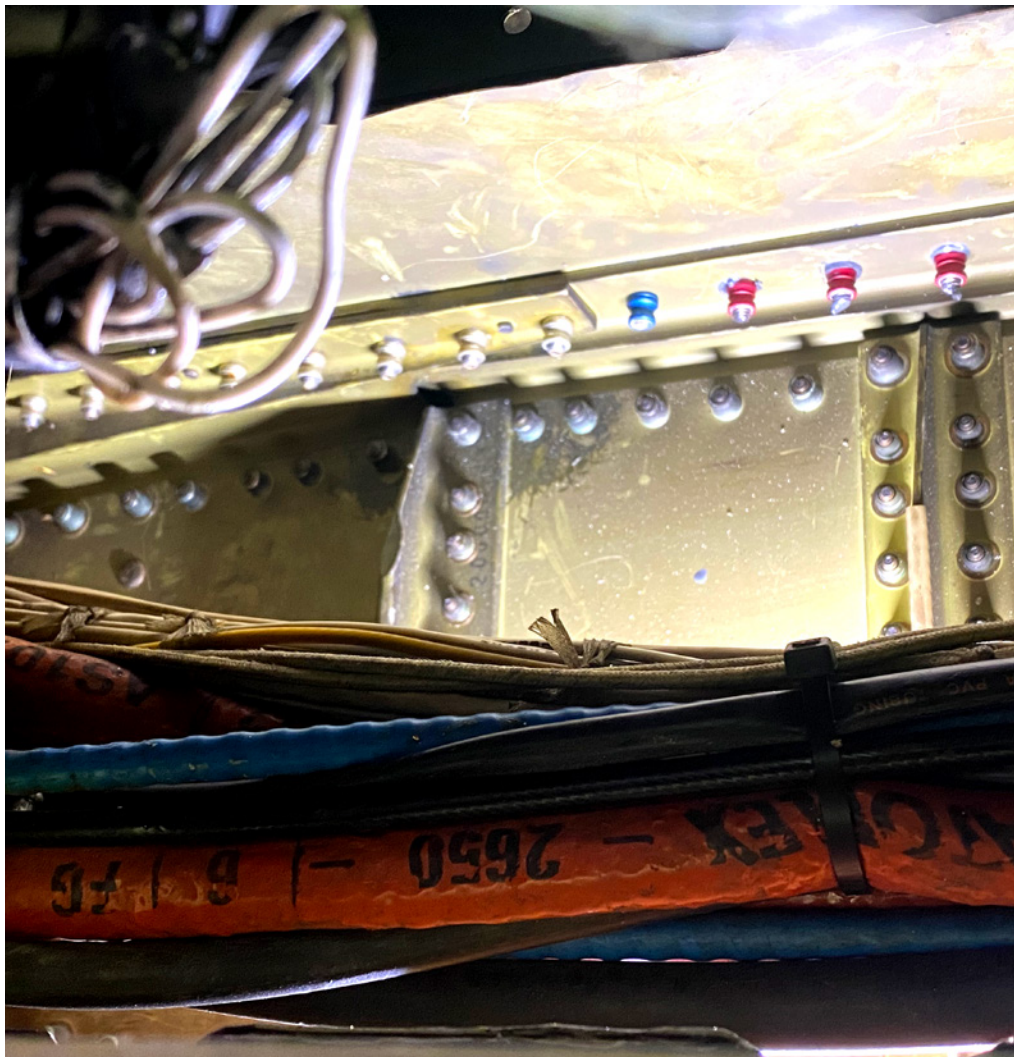
Bottom

Shows the cut out in the forward intercostal that is performed to gain access to the forward spar flange.

The picture with red hose on bottom shows the cutout in the forward intercostal for gaining access to the forward spar flange. This access point is later reinforced around the perimeter, and an inspection plate is installed. This picture also illustrates the Hi-Lok's installed in the upper

flange. Note the different colored collars denoting the size of the Hi-Lok utilized (i.e., standard, first-oversize, or second-oversize). After insertion, the GO-NO-GO protrusion gauges are placed by Hi-Lok to check for proper length before torquing the collar and then again after. The picture on the previous page illustrates some of the "mapping" required to track the appropriately sized fasteners by length and diameter. After all the fasteners have been installed and the final quality assurance inspection is performed, it is time to do some cosmetic work. The doublers are sealed with BMS 1422, and engine to wing nacelles are reattached. A thin bead of flexible, paintable seam sealer is used around the edges of the nacelle fairings. Lightweight filler is used as required in areas over the spar caps (where missing) to restore aerody-

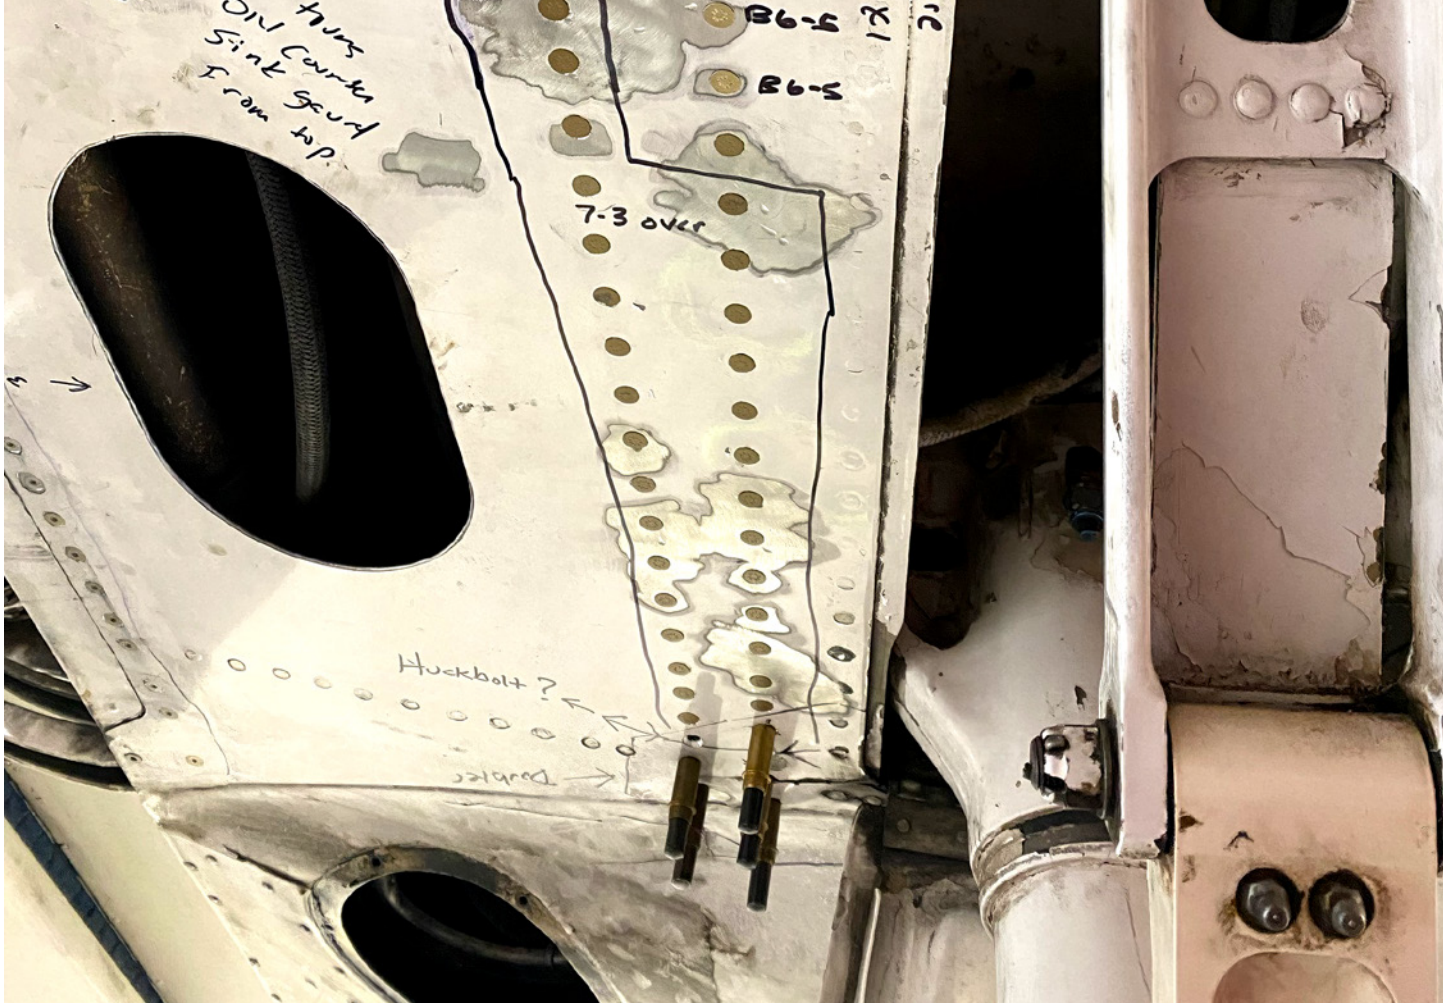
Opposite

“Mapping” required to track the appropriate sized fasteners by length and diameter required.

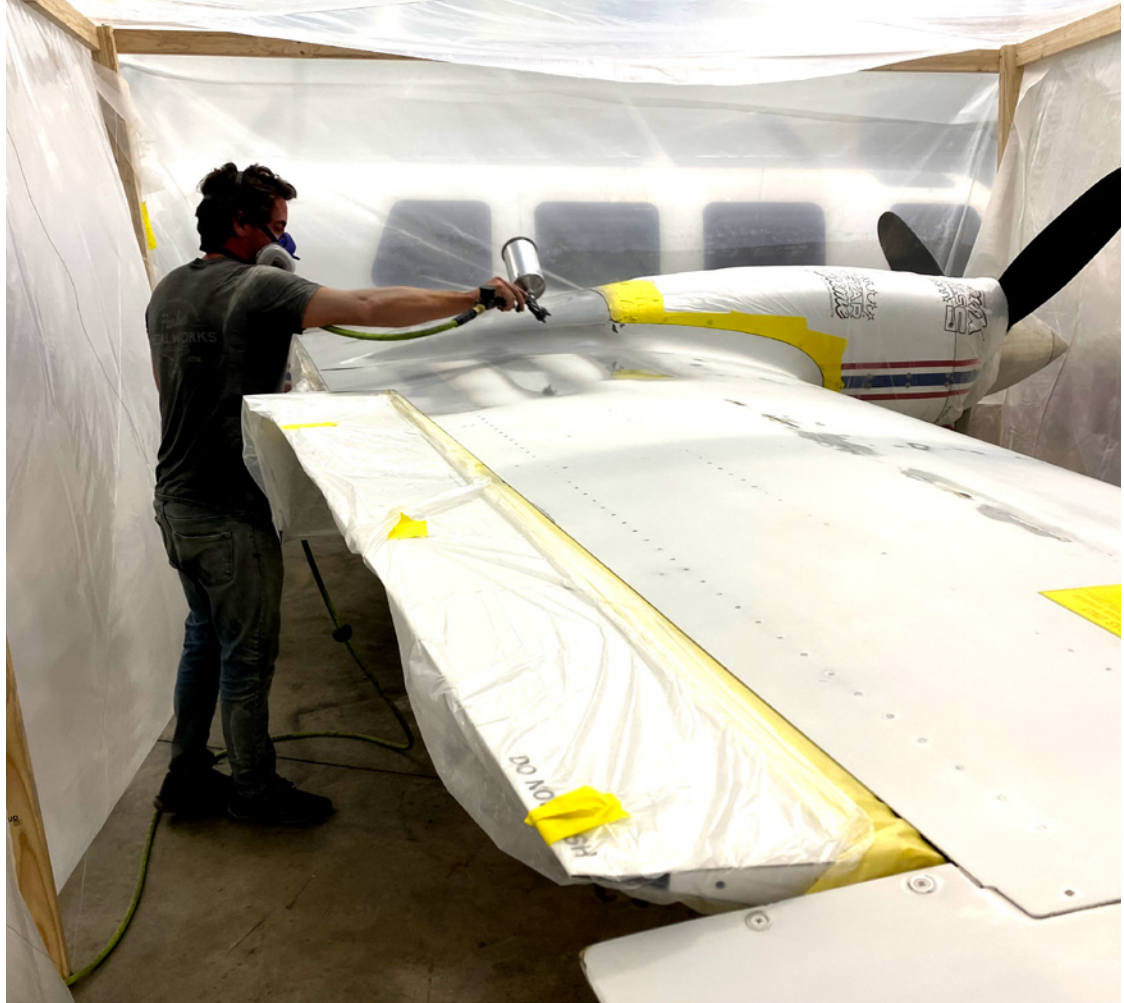
Priming and painting complete the repair.
